Monitoring Data Record

Project Title: R-2552B Clayton Bypass COE Action ID: 200220745

Stream Name: Site 5 DWQ Number: 041760

City, County and other Location Information: US 70 Clayton Bypass from I-40 to US 70

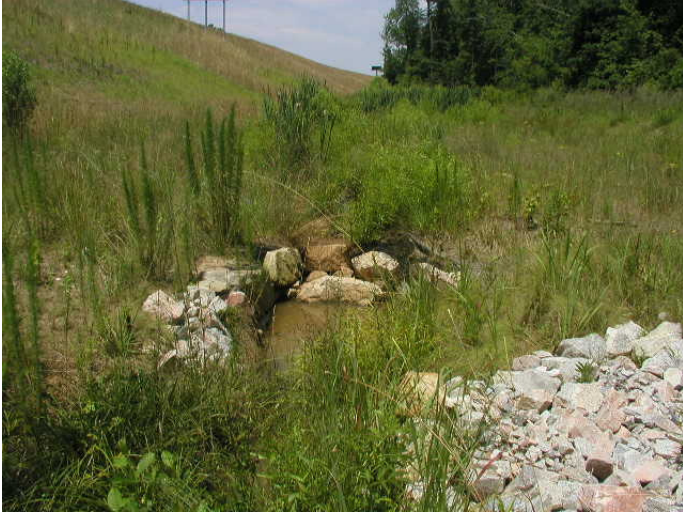
Photo Point #4 (Upstream)

The stream relocation is stabilized for the Year 2 summer evaluation. The second cross vane upstream (Photo Point #4 Upstream) from the box culvert that was noted last monitoring evaluation with a slight headcut and water piping under the crossvane has been repaired. However, at time of monitoring water was piping under this cross vane. This may be due to low water flow at time of monitoring. NCDOT will continue to monitor channel stability at this stream relocation.

Date 6/19/08	Station Number 11+00 –S-	Station Number	Station Number	Station Number	Station Number
Structure Type	Crossvane				
Is water piping through or around structure?	Water is piping under crossvane				
Head cut or down cut present?					
Bank or scour erosion present?					
Other problems noted?
